**Asbestos Management Survey**  
**Azelin Court**  
**Swindon**  
**SN3 4YE**  
**Externals To 4 Blocks Only**

**Date: 24<sup>th</sup> June 2024    Expiry Date: 24<sup>th</sup> June 2025    Prepared by K Howell    Reviewed by C Jelfs**

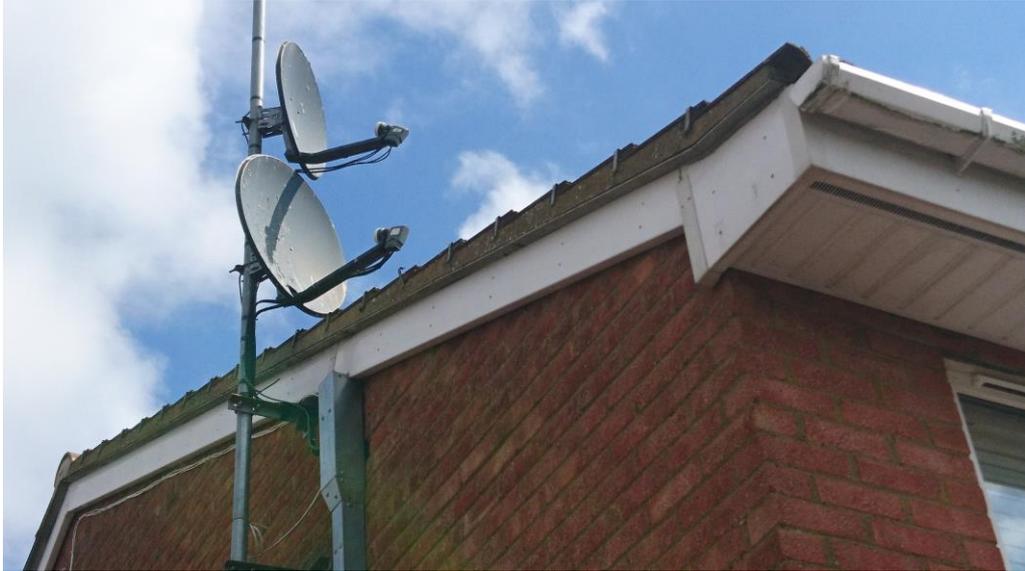
<b>Client</b>			
<b>Survey Address</b>	Azelin Court Swindon SN3 4YE		
<b>Location/Item</b>	E01 Externals cement undercloak to high & low level roofs on all 4 blocks		
<b>Reference Number</b>	1		
<b>Sample Number</b>	001		
<b>Photo Details</b>

<b>Risk Matrix</b>			
<b>Asbestos Type</b>	<b>1</b>	<b>Product Use</b>	<b>1</b>
<b>Condition</b>	<b>1</b>	<b>Surface Treatment</b>	<b>1</b>
<b>Material Risk</b>	<b>4</b>	<b>Action</b>	<b>Mark and Manage</b>
<b>Priority Assessment</b>			
<b>Accessibility</b>			
<b>Amount/Extent</b>	<b>130 LM</b>		
<b>Surveyors Notes</b>

Sample No.	Sample Ref.	Location	Asbestos Detected	Asbestos Type
1	BS981108	Cement undercloak	Yes	Chrysotile

Floor	Area No.	Area Description	Sample Number/Item Reference	Material Description & Location	Average Scores				Product Type 1, 2 or 3	Damage 0, 1, 2 or 3	Surface Treatment 0, 1, 2 or 3	Asbestos Type 0, 1, 2 or 3	Risk Score	Recommendation Mark and Manage Encapsulate Remove Exercise Caution	Action Date
					Activity within Area 0, 1, 2 or 3	Likelihood of Disturbance 0, 1, 2 or 3	Human Exposure Potential 0, 1, 2 or 3	Maint Activity 0, 1, 2 or 3							
G	E01	Externals	Sample 001/R1	Cement undercloak to high and low roof gables on 4 blocks	0	0	0	0	1	1`	1	1	4	Mark and Manage
